Research Summary

In-Situ Performance Verification of Cabeza Road, Nordheim, Texas

Field Structural Performance Study

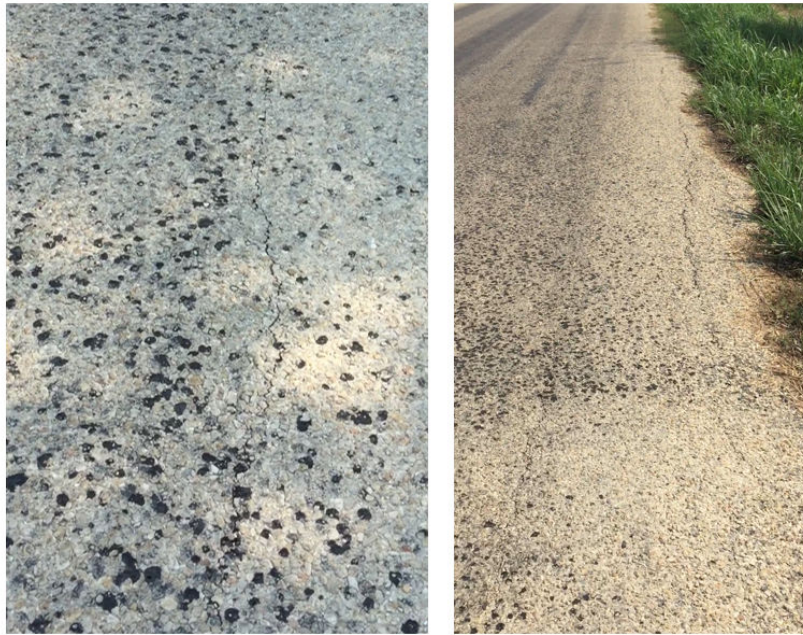
Ingios Geotechnics performed Resilient Modulus (Mr), Modulus of Subgrade Reaction (k), and Ev1 and Ev2 testing on the sections. Visual observations were also made. After a year of trafficking and heavy rain, results from the study showed both TX5 and TX130S are significantly enhancing the performance of the roadway by preventing permanent deformation, and reducing longitudinal cracking. The TX130S sections yield about ¼ the permanent deformation of the control section for the same level of stress. The control section displayed longitudinal cracking in both the wheel path and along the edge of the road (Figure 1). There was minor longitudinal cracking noted near the edge of TX130S section, adjacent to the control section. The TX5 stabilized section had no cracking, even though the subgrade was weakest in this section.

Figure 1: Longitudinal cracking observed in the wheel path and along the shoulder of the control.
