# SAVANNAH RIVERBANK PROTECTION PROJECT

## Observations on Cost, Constructibility and Performance

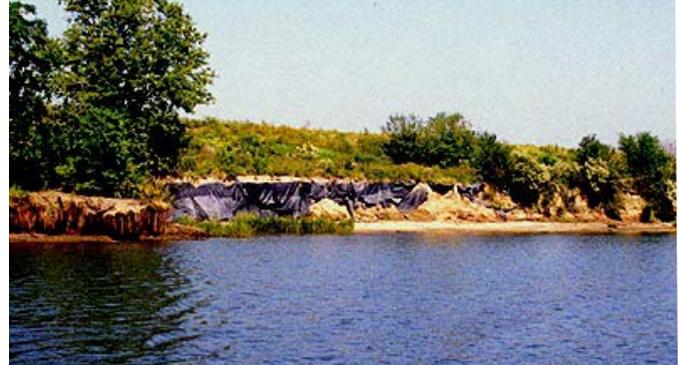
**PROJECT INFORMATION:** Four The project site is located along the north bank of the lower Savannah River, downstream from The Port of Savannah and the City of Savannah and between five and ten miles upstream from Tybee Island where the River empties into the Atlantic Ocean. The Georgia Department of Transportation and the U. S. Army Corps of Engineers have worked to maintain a 42 foot depth for shipping traffic on this portion of the river. Dikes immediately adjacent to the north riverbank provide containment for dredge material and have been threatened as evidenced by actively eroding bluffs along the riverbank. (See Figure 1)

*Fig. 1: Bluff eroding into containment dike along north bank immediately upstream from test sites. Geotextile was previously placed within embankment.*

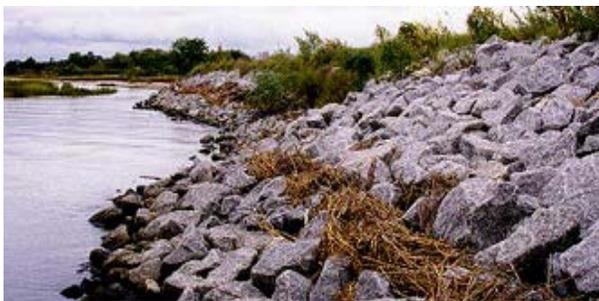
In one area of Section B the riprap appeared to suffer a loss of toe support and subsequent settling or slumping. Additional riprap material has been placed as a repair and the settling or slumping appears to continue. (See Figure 2)

Figure 2: Riprap installation at Section B. In the vicinity of the vegetation in the center of the photo, slumping continues despite repairs by adding riprap.

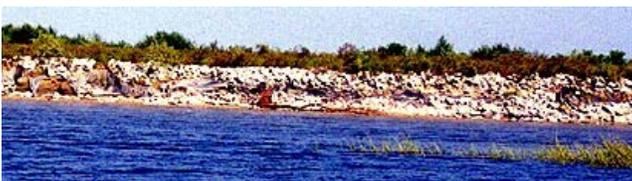
Section E sustained loss of riprap material, shredding of the underlying geotextile, and loss of embankment material near its upstream end. Due to the extent of damage it is difficult to ascertain the mode of failure with certainty. Given its nature and location, the failure appears to have the potential to propagate along the riverbank. (See Figures 3 & 4)

Figure 3: Upstream portion of riprap installation at Section E. This area experienced major washouts.

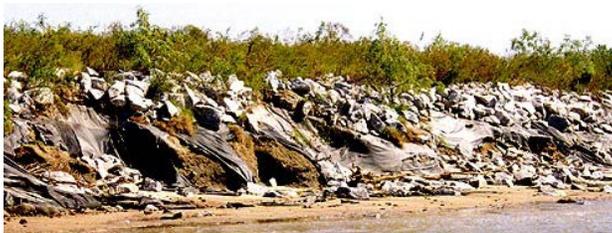
Figure 4: Close-up view of riprap failure at Section E.

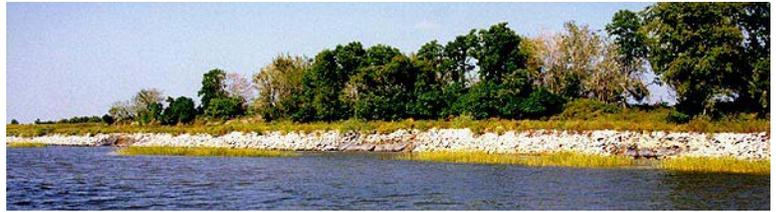
Section G sustained similar damage over three distinct stretches of riverbank which appear to be actively spreading. See Figures 5, 6, 7, 8.

Figure 5: Downstream portion of riprap Section G. This section experienced three distinct failed areas. Left is upstream, right is downstream.

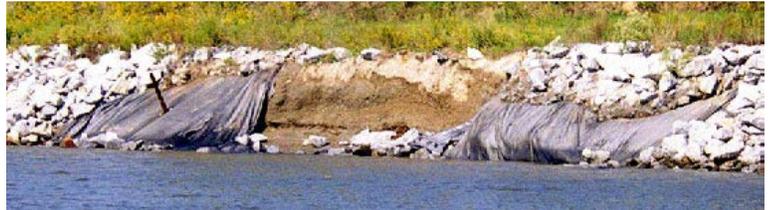
Figure 6: First (upstream) failed area at riprap Section G

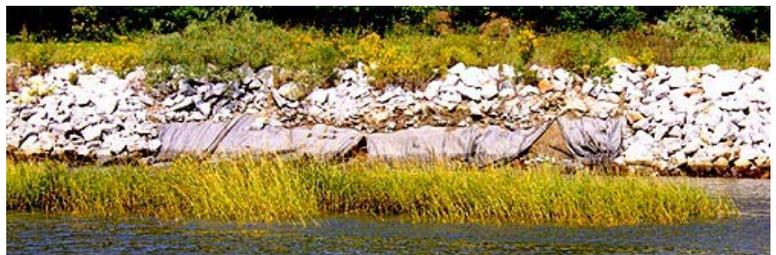
Figure 7: Second failed area at riprap Section G.

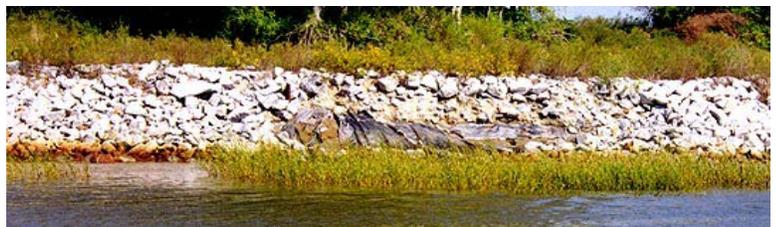
Figure 8: Third failed area at riprap Section G.

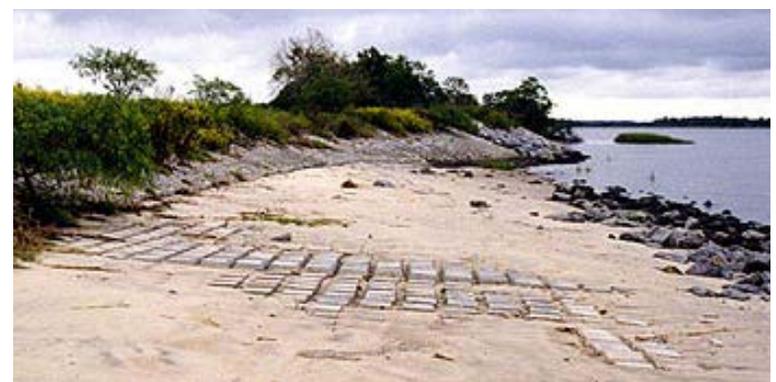
**CABLED BLOCK MATS:** Sections A and D were constructed using a proprietary form of cabled block mat. The river has been accreting at Section D such that much of the block mat is now covered with sand deposits. Overall this site looks good and does not appear to have been seriously challenged by the river. (See Figure 9)

Figure 9: Cabled block mat Section D looking downstream. This site has been depositional, as evidenced by the sand deposits covering the armor layer.

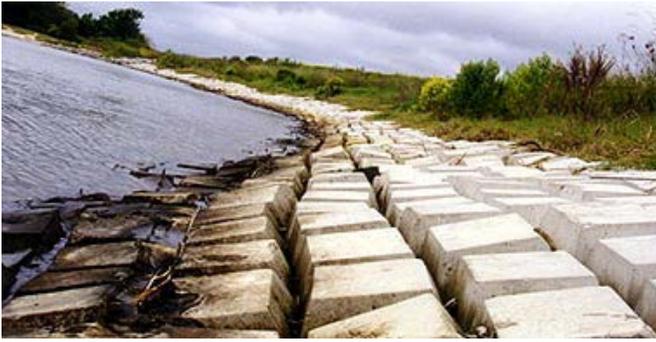
Figure 10: Cabled block mat Section A looking upstream. This site has been erosional. Differential settlement and loss of intimate contact are prevalent.

Section A has experienced multiple types of failures. Much of the installation shifts underfoot as there is widespread loss of intimate contact with the subgrade. In some areas, particularly near the water line, wide voids several inches in depth have developed beneath the blocks. The inherent tendency of the cables to restrict flexibility is evident in the many suspended, rocking blocks. The irregularities in the subgrade appear to be caused by differential settlement or erosion of the subgrade. For such challenging hydraulic conditions, this loss of contact between the blocks and the filter / subgrade is typically defined as a failure in itself, signaling the onset of more dramatic failure.

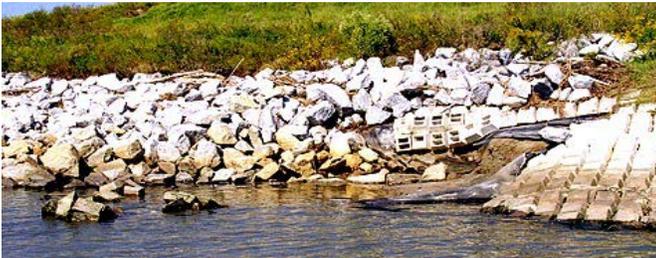
Figure 11: Cabled block mat washout at the flanking transition on the upstream end of Section A.

In other areas the mats have heaved or flipped due to inadequate hydraulic stability. The hydraulic stability appears to be least where settlements have led to protruding blocks and where there are wide gaps between the mats. This observation is consistent with the theory of increased drag and uplift forces on protruding blocks. Early attempts to stem the problems by grouting between the blocks were largely unsuccessful. On the upstream end of the section, the mats and embankment have washed away, and failure appears likely to propagate downstream. (See Figures 10 - 13)

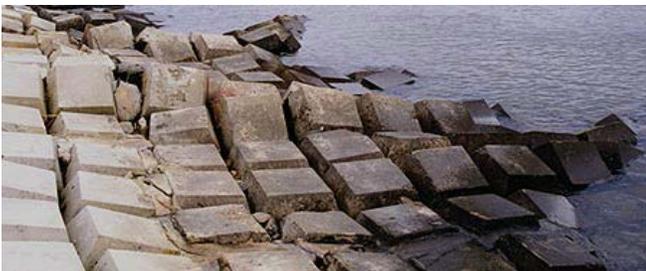
Figure 12: Heaving of cabled block mat on the upstream portion of Section A.

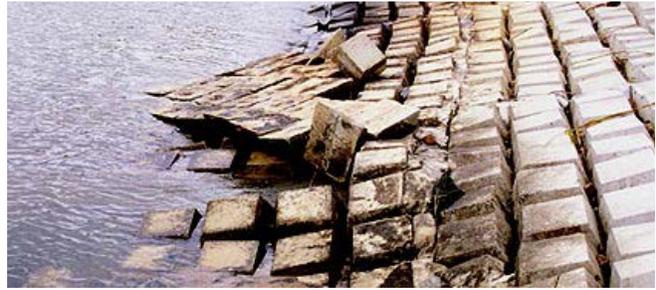
Figure 13: Flipping of cabled block mat on the upstream portion of Section A.

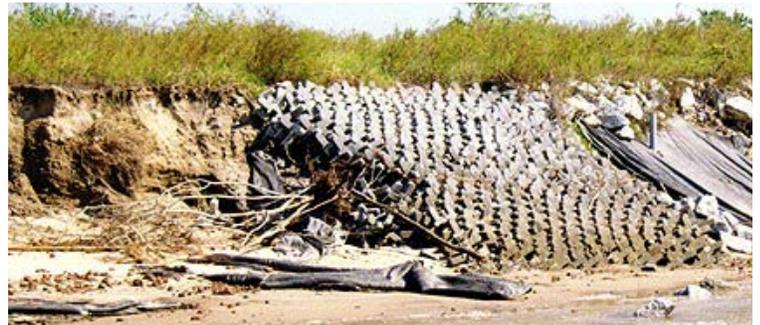
**TETRAPODS:** A proprietary form of tetrapod was used as flanking for both ends of Sections C and E, for a total of four locations. The tetrapods were considered to be the most costly and difficult to construct of all the options tested, but were evaluated for use in special cases such as flanking. Major failure resulted at both tetrapod installations on Section E. The upstream flanking appeared to be failing progressively from the upstream end toward the downstream end, as would be expected in the case of undermining and hydraulic instability; the upstream end is arching fairly rigidly over a void created by undermining. Fragments of broken tetrapod units were seen scattered downstream. The downstream flanking appeared to be failing progressively from the toe upward, as would be characteristic of a loss of toe support and subsequent separation and loss of interlock. The results observed on this project raised questions regarding their suitability for use in conditions such as these. (See Figures 14 - 16)

Figure 14: Washout of tetrapod units at upstream flanking of Section E. Upstream edge is undermined and generally not flexing with the subgrade.

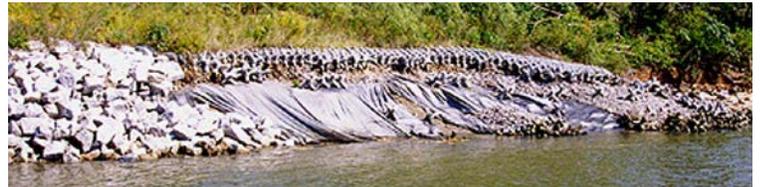
Figure 15: Washout of tetrapod units at downstream flanking of Section E. Failure appears to have developed from the toe.

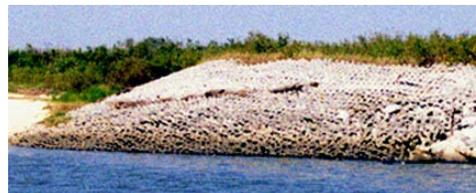
Figure 16: Tetrapod flanking of Section C performed better and remained intact.

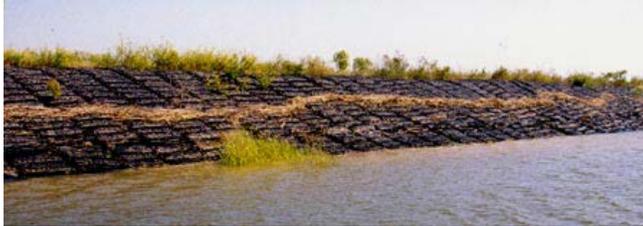
**MARINE MATTRESSES:** Marine mattresses were used to construct Sections C and F. The performance of the marine mattresses surpassed that of the other alternatives used. The preliminary design report by Olsen Associates, Inc. states that “The most important performance criteria for an erosion control structure is its inherent stability.” On this project, only the marine mattress consistently demonstrated stability. (See Figures 17 & 18)

Fig. 17: Marine mattress Section C looking downstream. Each unit is anchored at top of slope by burying an extending tail of geogrid. Pairs of units are spliced together end to end. Stability has been maintained throughout.

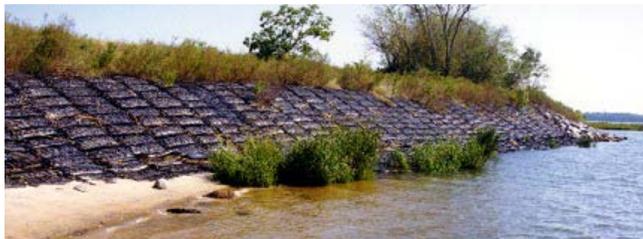
Fig. 18: Marine Mattress Section F looking downstream. Stability has been maintained throughout.

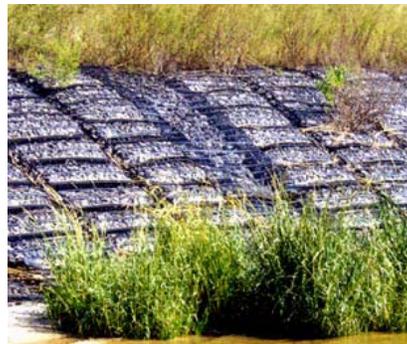
Second, the side-to-side gaps between marine mattress units are excessive in some cases; in one notable case, the patch over the gap was inadequate. These types of problems are addressed in the repair document mentioned above. (See Figure 20)

Fig. 20: An excessively wide gap at the side-to-side joint between marine mattress units has been repaired by filling the gap with stone and braiding a geogrid patch in place over the stone. Lesson learned: due to the excessive width of the gap, baffles are needed to prevent movement of stone down the slope.

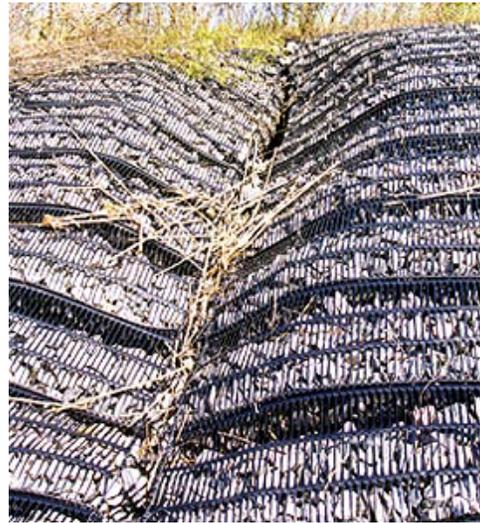
Last, investigation of a large void beneath two marine mattress units indicated faulty installation of the geotextile filter. It appears that in the immediate vicinity, the geotextile beneath the units was discontinued. Although the gap in the geotextile coverage was in the upper portion of the slope, the

subgrade apparently eroded during a high water event and the void propagated, primarily downslope beneath the geotextile. The development of the void is considered directly attributable to the missing geotextile. Grouting should be considered to fill the void and future grouting may be required, depending on the lateral extent of the missing geotextile. (See Figure 21)

Fig. 21: A void two to three feet wide and two to three feet deep had developed beneath two units and near the top of the slope. Video inspection of the void showed that the geotextile underlayer was missing and apparently had not been placed. The upper edge of the geotextile was found at the lower end of the visible gap (the top third of this photograph). The void had propagated downslope.
