TrackTex™ Anti-Pumping Geocomposite Excels in Multi-Year Test

Mud Spot Remediation on Trackbed Performance Test

Christianburg, VA

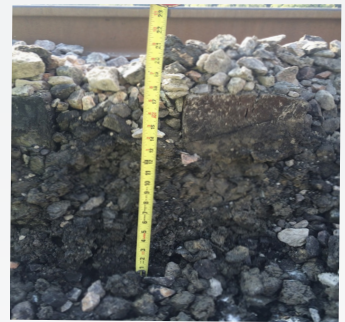
Just two years after the track renewal (before TrackTex installation) the ballast was severely fouled to a 14 in. depth due to mud pumping from poor subgrade.

All three sections of track had been undercut and renewed with clean ballast within the previous two years, but track settlement problems were already recurring with mud visible at the surface.

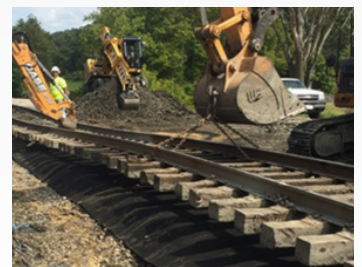
The track was lifted and TrackTex was simply slid into position with no requirement for special equipment.

At each location the track was undercut to a depth of approximately 12" to 14". The track was lifted and the TrackTex geocomposite simply slid under the track, meaning minimal time added to the overall renewal operation. The new ballast was placed and tamped to a shallow depth to avoid damage to the TrackTex, and the associated drainage ditches were cleaned and reprofiled. Following this renewal, a detailed monitoring period ran for two and a half years. During this time there was approximately 60MGT of traffic with a timetable speed of 40 mph.

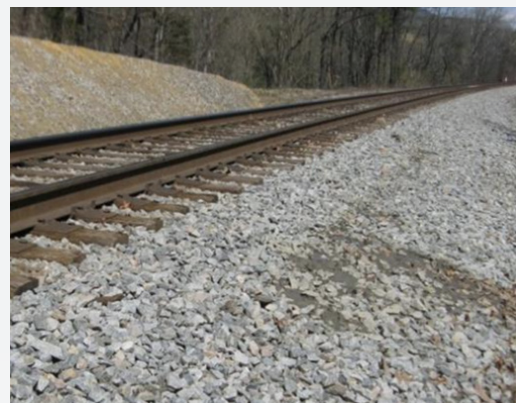
Mud boils were visible in the shoulder 2 years after TrackTex installation. They formed below the level of the TrackTex since it keeps mud from the ballast.

In March 2016 the 18 month inspection of the test sections reported in all locations the track surface and ballast condition was excellent, with no signs of degradation. It was observed that mud had appeared at one of the locations in the low-side shoulder of the track, but this was below the TrackTex installation depth and the analysis was that the TrackTex was preventing the mud pumping into the ballast section, which remained clean and structurally sound.

In April 2017 the shoulder boils were removed for detailed investigation. Excavations by hand found mud had penetrated the shoulder leaving the ballast there impacted by firm clay. However the ballast under the ties and in the crib was wet but free of fine grained material. When the TrackTex was exposed it was observed that water was running continuously from beneath the TrackTex.

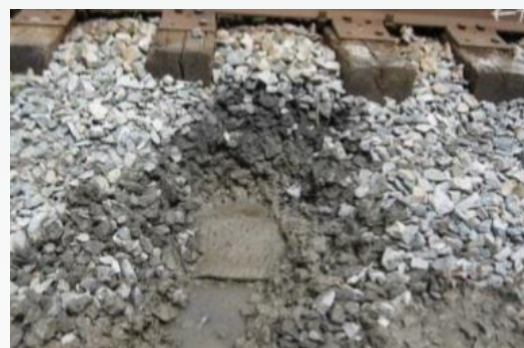
TrackTex exposed, ballast above is wet and free from fines, but the shoulder outside the TrackTex has been recontaminated with mud from the weak subgrade.

The final Engineer report concluded that TrackTex performed very effectively, completely covering very weak substructure including a low spot and saturated subgrade. The ballast on top of the TrackTex was wet but clean, showing it had stopped upward movement of fines thus preventing the subgrade from fouling the ballast section.

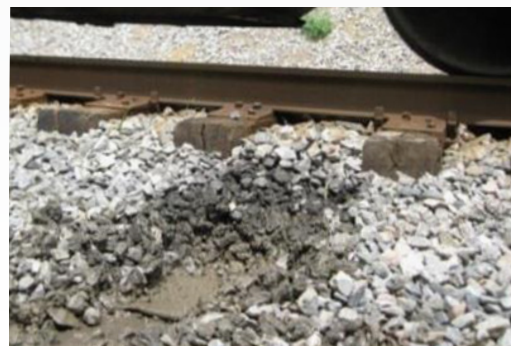
Even where track was observed to have dropped there was no movement evident under traffic.

In one area it was noted that even though the track profile had dropped, the track and subgrade were both solid, and there was no track movement evident under traffic.
