Triton Marine Mattresses offer non-corrosive stream restoration solution for nearly 20 years

California Gulch

Leadville, Colorado

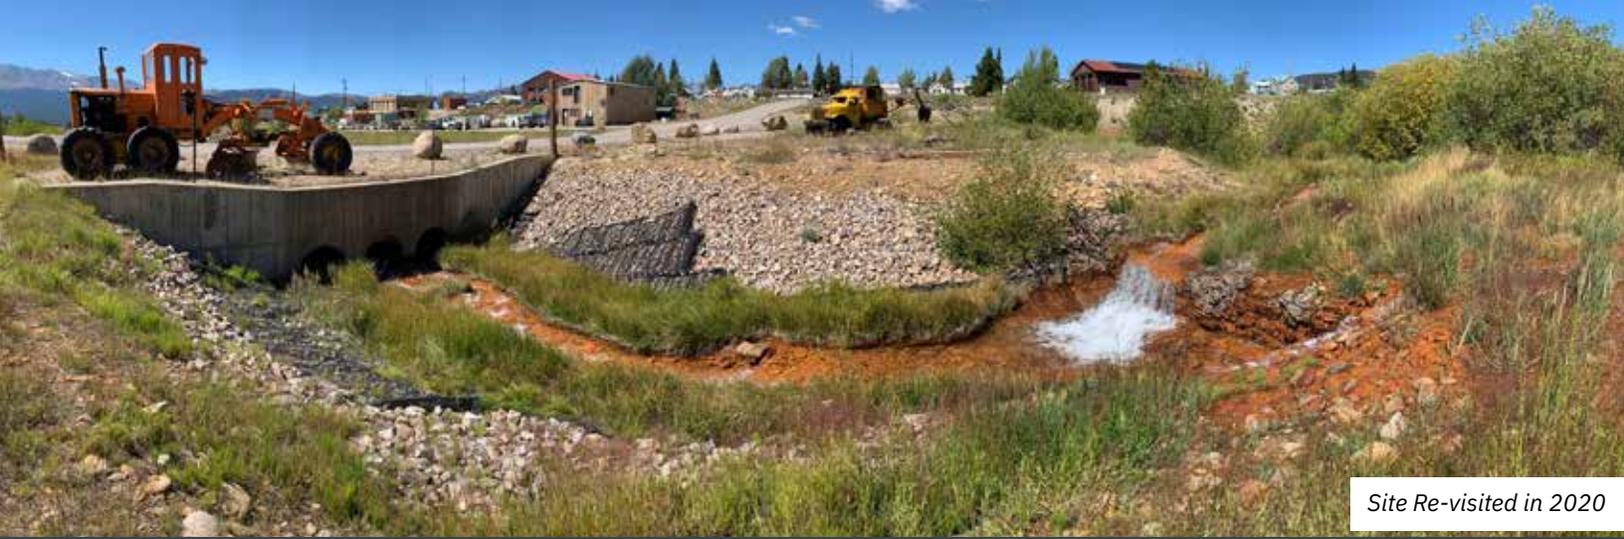
Site Re-visited in 2020

The site was revisited in September of 2020 with the goal of inspecting the job site to determine how well the mattresses had performed after weathering 18 harsh Colorado mountain winters. Visual inspection showed the mattresses had remained stable with no movement or settling. No erosion or scour was observed. Triton marine mattresses had proven to be a highly effective solution for this once problematic site.
