# NCAT Pavment Test Track

## Opelika, Alabama

**APPLICATION:** Asphalt pavement reinforcement for National Center for Asphalt Technology (NCAT) test track.

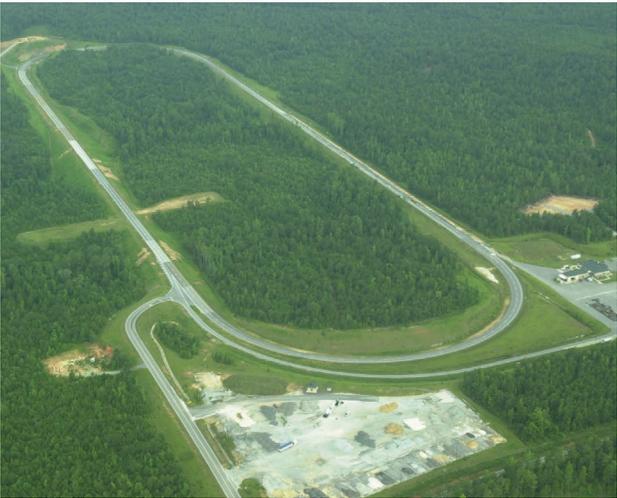
The GlasGrid Pavement Reinforcement System was installed at the National Center for Asphalt Technology (NCAT) pavement test track in Opelika, AL.

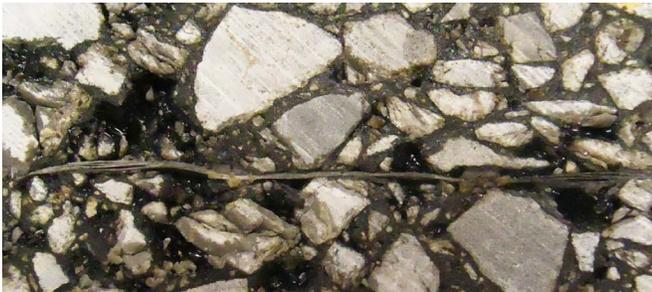
Core sample showing GlasGrid 8501 bonded to the sandwiching layers of SMA mix.

A core sample removed prior to the main excavation revealed that the GlasGrid was still intact and bonded to the sandwiching layers of the SMA mix (see photo next page). Buzz Powell, Test Track Manager of the NCAT organization, noted “GlasGrid did not create any problems during the installation of the product.”

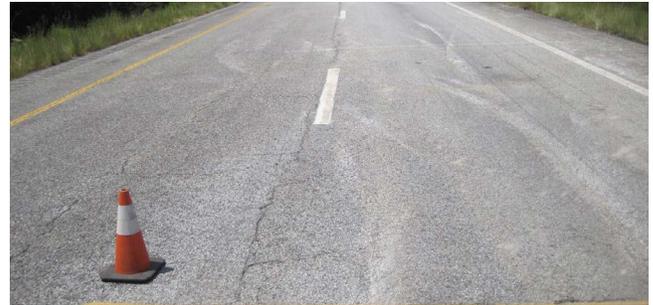
During the 2018 site visit, additional cracking was observed in the unreinforced section.

**2018 SITE FOLLOW-UP** The NCAT site was visited once again in 2018 after 60 million ESALs of loading. Observations revealed that the unreinforced section had more cracking present in addition to the joint cracking first observed in 2006. Also, there was now random cracking within the lane area as well as additional cracking extending from the centerline cracking. As for the GlasGrid reinforced section, cracking was now appearing, however, it is limited to only the 18 year old construction joint.

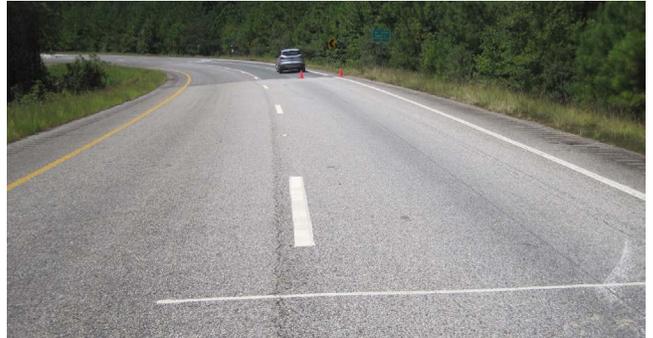
The GlasGrid reinforced section was also evaluated in 2018. After 60 million ESALs, cracking was starting to appear but limited to the 18 yr. old construction joint.
