## Driving progress on sustainable access road

# Uungula Wind Farm

Twelve Mile Rd, Wuuluman NSW 2820

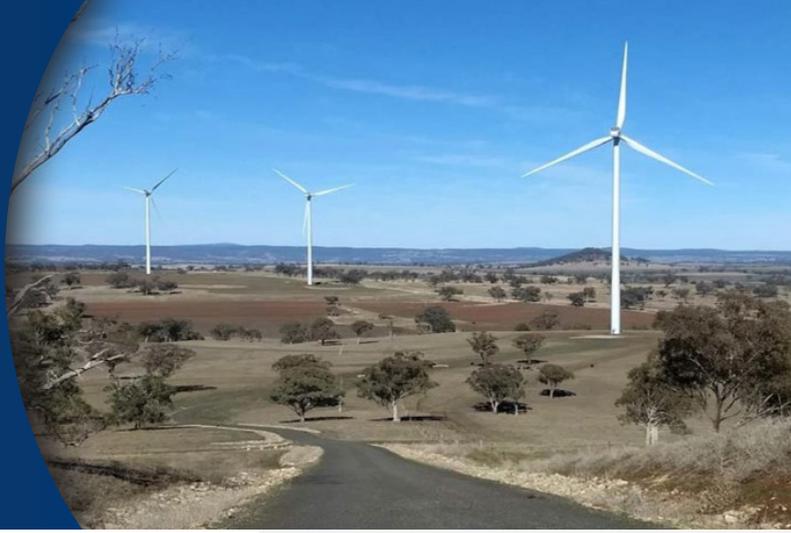
After considering the site conditions and available materials, Tensar proposed a mechanical stabilisation solution utilising a single layer of large-aperture Tensar InterAx geogrid to meet the design requirements of 10,000 ESALs and a minimum CBR of 3%. The client chose to incorporate an additional layer of Class A geotextile for separation. The adaptability of this solution resulted in a 40% reduction in construction costs compared to lime stabilisation.

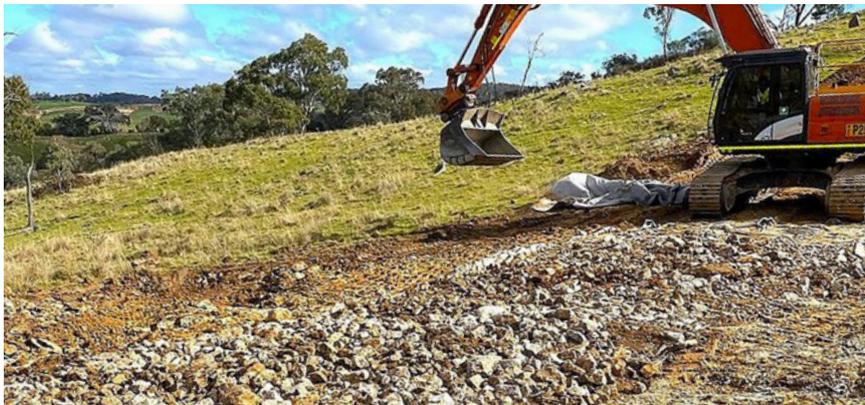
NXL 1 x layer with Class A geotextile used

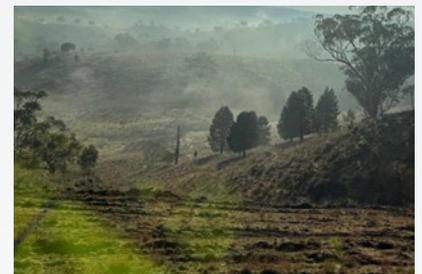
General Site conditions (Prior to construction)

Temporary access road construction was challenging due to underlying soft soils with a CBR of 1–3%. The original proposal, which involved lime stabilisation, was costly because of limited resources and community concern around increased truck movements. The client was seeking an alternative solution, bearing in mind that the on-site crushing facility was only producing 75–150 mm aggregate.

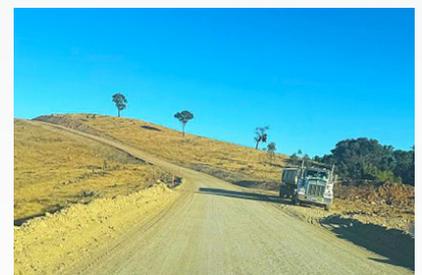
After shot
