# GlasGrid Delivers Long-Term Performance on New York Roadway

## County Route 41

Farmington, NY

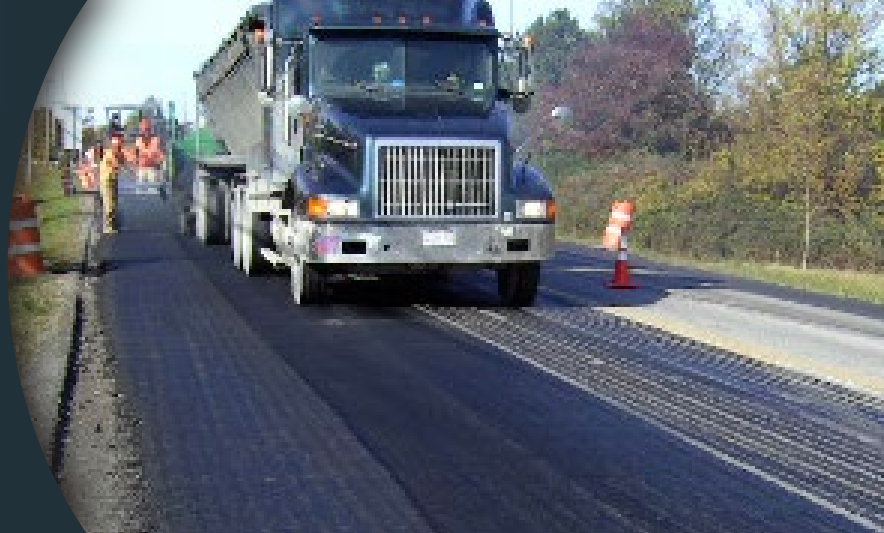
- Unreinforced paving joints showed separation, while GlasGrid-reinforced joints continued to perform well.
- By 2016, separation was observed only along the unreinforced paving joint.
- Transverse cracks remained localized near the pavement edge and generally terminated before reaching the GlasGrid reinforcement.
- Few, if any, transverse cracks extended across the full pavement width.
- Demonstrated the long-term effectiveness of GlasGrid® reinforcement in reducing reflective cracking and extending pavement performance.
